UNDERWATER FACILITIES
INSPECTIONS
AND
ASSESSMENTS
AT

TRIDENT REFIT FACILITY
NAVAL SUBMARINE BASE
BANGOR, WA

FPO-1-83-(36)

SEPTEMBER 1983

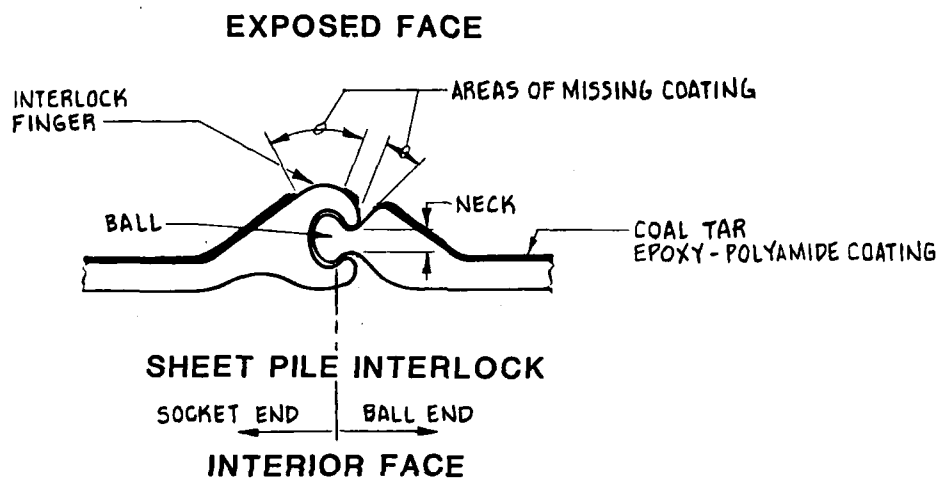
COATING CONDITION SHEET PILE INTERLOCK

The major anomaly noted was the loss of coating on the sheet pile interlocks. Specifically, the exposed curve of the finger and the intersection of the finger and the neck (see Figure 6 and Photos 5 through 9). The worst coating loss on the exposed interlock finger is at Cell 7, Cell 9 and Arc 8/9 where 50% of the coating on the finger is missing between elevation +4.0 and the mudline. At Cell 8 only 25% of the coating is missing from the interlock finger. Over the remaining cells and arcs coating loss on the interlock fingers ranges from 5 to 15 percent and is sporadically located between elevation +4.0 and the mudline. Maximum coating loss on the webs of the sheet piling was also observed between Cell 7 and Cell 9. Loss of coating was found over 3% of the web area between elevation +4.0 and the mudline. Over the remaining cells and arcs coating loss on the webs was less than 1% of the surface area (see Photo #10).

In general, coating loss at the intersection of the interlock finger and the neck (see Figure 6 and Photo #11) was observed at all sheet pile interlocks.

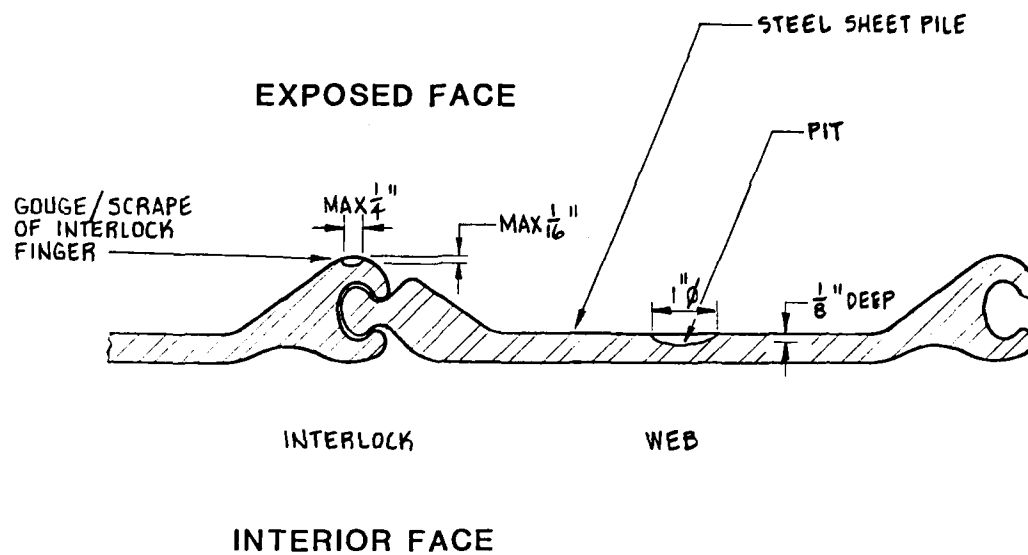
**OBSERVED PIT & GOUGING
OF STEEL SHEET PILING**

The only anomalies noted on the sheet piles were some minor pitting and/or scraping of the steel. One pit, (Cell 7, Sheet 28 clockwise from wye pile, elevation -8.0) was fairly deep, approximately 1/8", and approximately 1" in diameter. The pit did not appear to be the result of corrosion but the result of a deficiency in the steel, perhaps a slag pocket (see Figure 7 and Photo #12).

The fingers of several pile interlocks have long (up to 24") gouges 1/4" wide by up to 1/16" deep (see Figure 7). These gouges are felt to be preconstruction conditions, perhaps the result of the rolling process, since in many cases the coating is intact over the gouge.

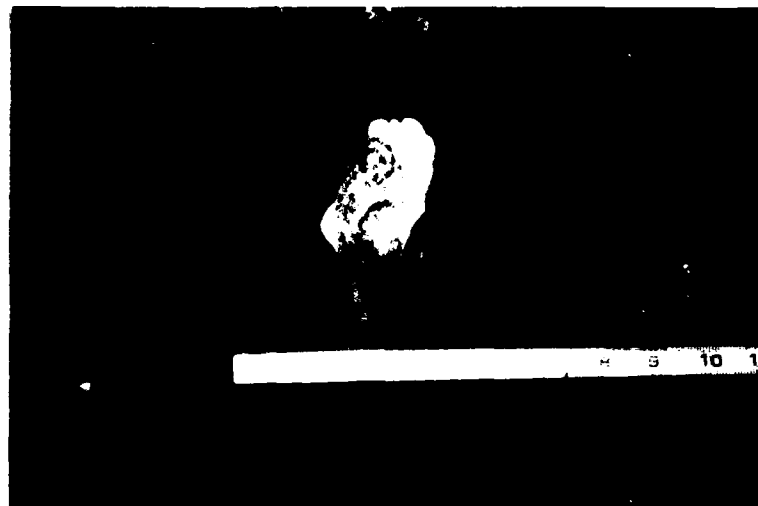
PHOTO #12: Cell #7, sheet 28 cw, elevation -8.0
Pit in web of sheet pile approximately
1/8" deep by 1" diameter.

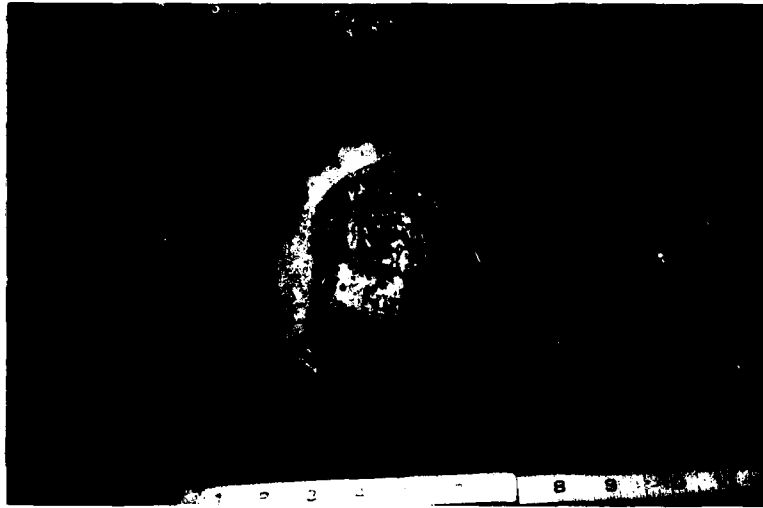
It was observed that in many areas where the coating is missing, there is a deformation of the steel. Usually this deformation is a dent or dish in the steel probably caused by impact from either a construction vessel or piece of construction equipment (see Photos 14 and 15). Usually the indentation is subtle and gives the appearance of significant metal loss. Thickness readings in these areas, however, indicated little or no metal loss.

PHOTO #14: Cell #8, sheet 36, cw, elevation -12.0
Coating loss at a dent in sheet pile web.

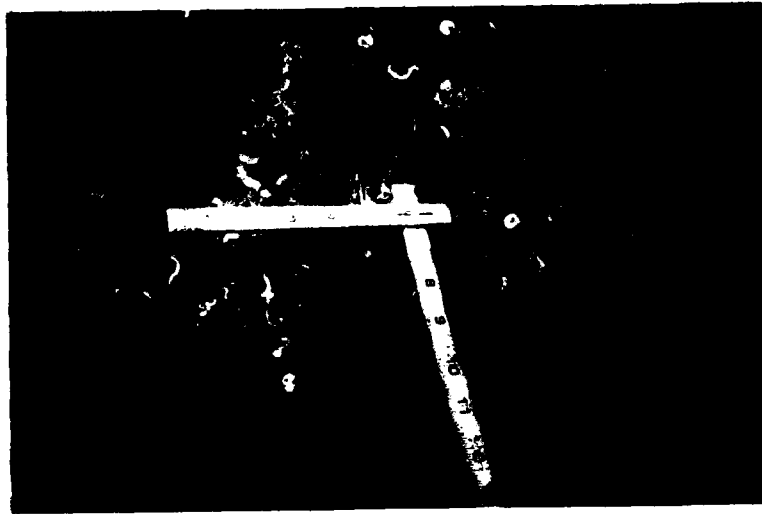
of insufficient vibration of the concrete during construction, were noted at the steel sheet pile/concrete connection of the west abutment (see Photo #21).

PHOTO #21: Cell #1/abutment Interface, elevation
-15.0

Cosmetic spalling at steel sheet pile/
concrete abutment interface.

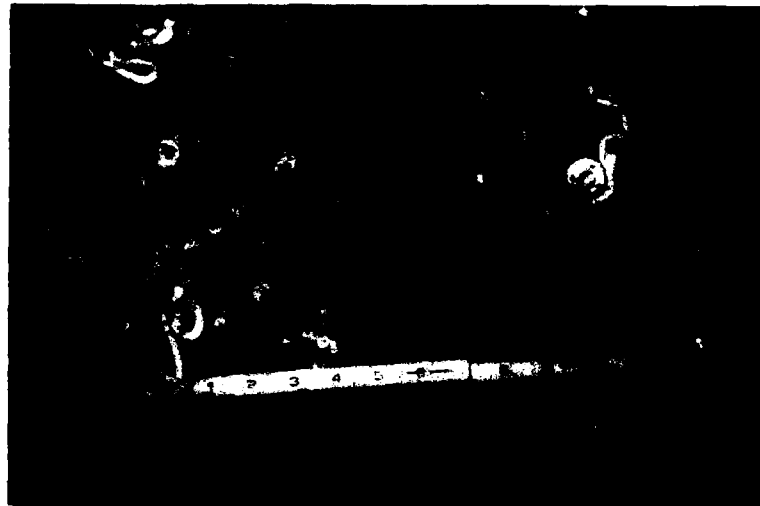
film over the metal (see Photos 24 and 25). Both of these observations are indications that the cathodic protection system is functioning.

PHOTO #24: Cell #5, sheet 37 cw, elevation -7.0
Dull gray film over bare metal.
